FAILURE BRIEFING

EROSION FAILURE OF STEEL FLANGES

ROGUE MATERIALS

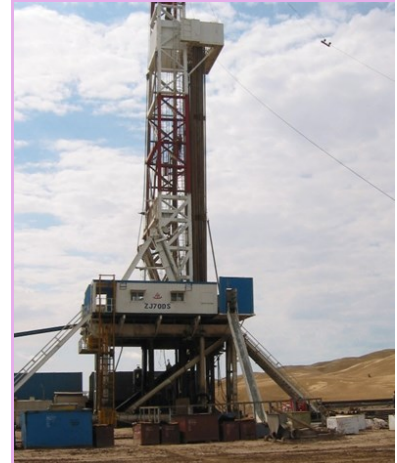
The drilling rig

The photo shows an onshore drilling rig used in desert regions. The installation contains reciprocating pumps used to pump highly-erosive mud slurry at high pressure (350 bar+) down the drill string.

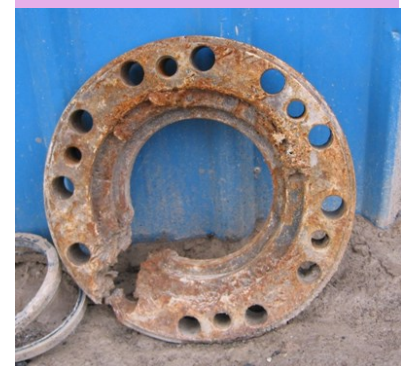
The failed flange

The photo shows one of the flanges fitted in the slurry circuit after only a few weeks operation. It has clearly been eroded away by the abrasive fluid. Components in the slurry circuit are accepted as being replaceable components but normally last longer than a few weeks

Component subjected to erosive conditions need to be either lined with plastic/rubber etc or made out of erosion-resistant materials. The forged steel material used for these eroded flanges (there were a lot of them) was found to not have the correct specified hardness (HB) value

as shown on the flange manufacturer's material test report (MTR). It varied from 30-40-% below the HB value shown. It was concluded that this was a major factor in its very short operating life under service conditions.

Don't believe that manufacturers' material certificates are all true. Some were prepared by people who will just tell you what you want to hear.

Do additional mechanical tests (impact, hardness and tensile strength as a minimum) on material you buy before you use it even if the material specification or application code doesn't require them. Cut the test pieces and witness the test results yourself. That way you will know what you are getting.
