## MATTHEWS INTEGRITY HUB

### FAILURE BRIEFING

#### CATASTROPHIC FAILURE OF A STEAM DIFFUSER; VIBRATION FATIGUE

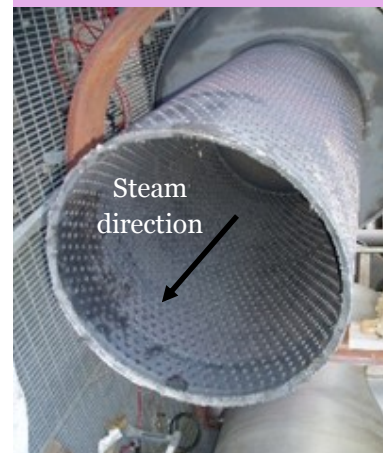
After one turbine trip the dump line was seen to be vibrating heavily where it entered the condenser, suggesting that the diffuser was no longer diffusing the steam. The plant was shut down and the diffuser accessed for inspection. The flat end the diffuser was found to be completely broken off in the circumferential plane (see photo).

Diffuser with end missing

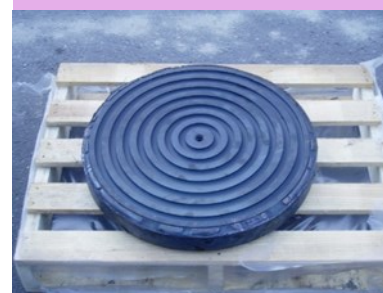
Diffuser end

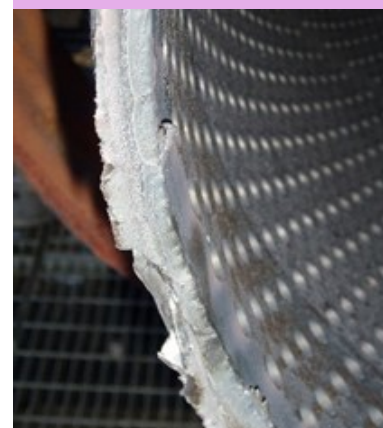
Fracture surface

The photo shows the fracture face as a classic vibration fatigue fracture. The crack starts as a flat surface showing 'beach marks' and then ends as a ductile 'tearing' failure showing shear lips. Once the failure occurred then it propagated instantly around the circumference giving the neat circumferential fracture.

The vibration was the result of the dump steam impinging on the flat end of the diffuser during repeated steam dumping. It was made worse by general mechanical vibration of the condenser steam duct in normal service.
