# MATTHEWS INTEGRITY HUB

## FAILURE BRIEFING

### MULTIPLE FAILURE OF STEAM DUCT WELDS

#### MECHANICAL FATIGUE

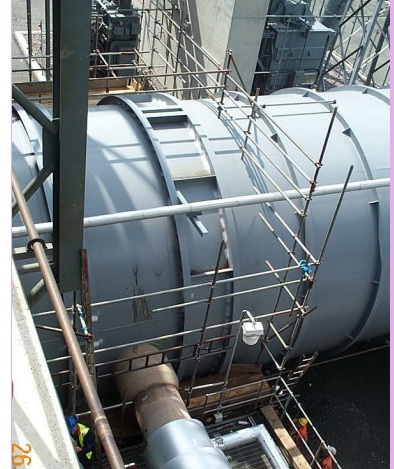
The power plant 7m diameter steam duct is constructed to ASME VIII-I for pressures of +1barG to full vacuum. Dump steam enters the duct through the inlet nozzle shown under some plant fault conditions. As the vessel is rated for full vacuum it has circumferential stiffeners to resist buckling

The steam duct

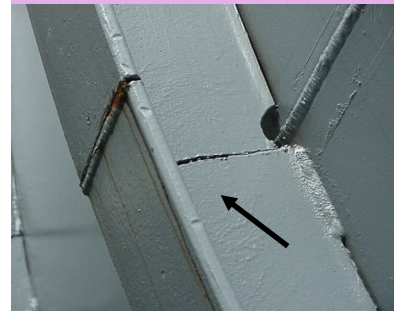
The photos show cracks propagating from welds. The stiffener crack had started from the mousehole spanning the vessel longitudinal weld, propagated up the stiffener web and continued along the toe of the stiffener flange.

Failed stiffener weld

This is a straightforward mechanical fatigue failure caused by flow-induced vibration of the duct. It had been observed to be vibrating heavily, particularly under steam dump conditions. The widespread nature and number of failures suggests that it was not a problem with individual welds.

For fabrications that have to exist in fatigue service, blending of the weld caps to a smooth profile can help reduce the risk of fatigue cracking. Peening of the weld surface can also help. Ultimately however the best long-term solution is to eliminate the source of the mechanical vibration.

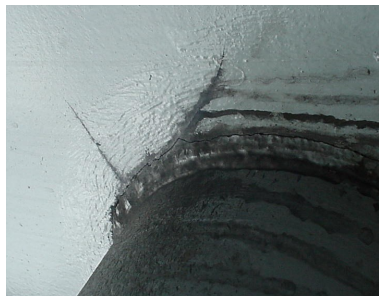
The asymmetric leg-length and rough convex profile of the nozzle-to-shell welds may be marginally outside code acceptance criteria but

these are regular features of ASME VIII-I fabrications. Overall it was considered unlikely that these had anything to do with the failure and that, under such severe mechanical fatigue conditions, failure was inevitable, whatever the quality of the welds
